Improving pedestrian access across State Highway 88

Christine Mockett, 3rd year BEngTech (Civil), 2020

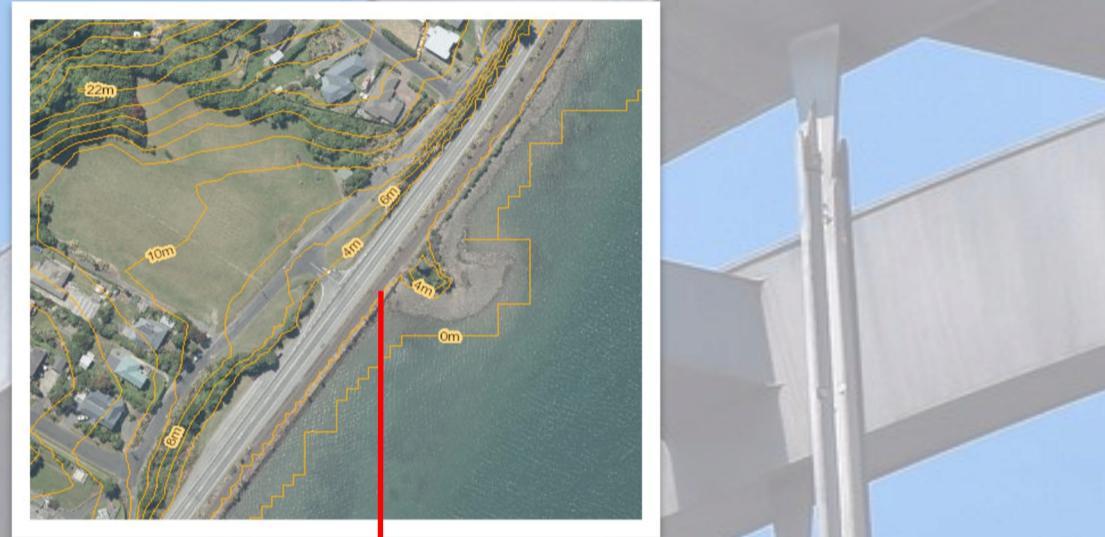
Figure 2 — Arial view and topography map of St Leonards Park next to SH88, DCC (2020)

A site assessment found that the most suitable location for a footbridge was in St Leonards, where there is St Leonards Park on one side of SH88 and a rocky outcrop on the other side of SH88, as seen in figure 2 and figure 3. This location utilized the natural land features, reducing the costs of constructing a bridge.

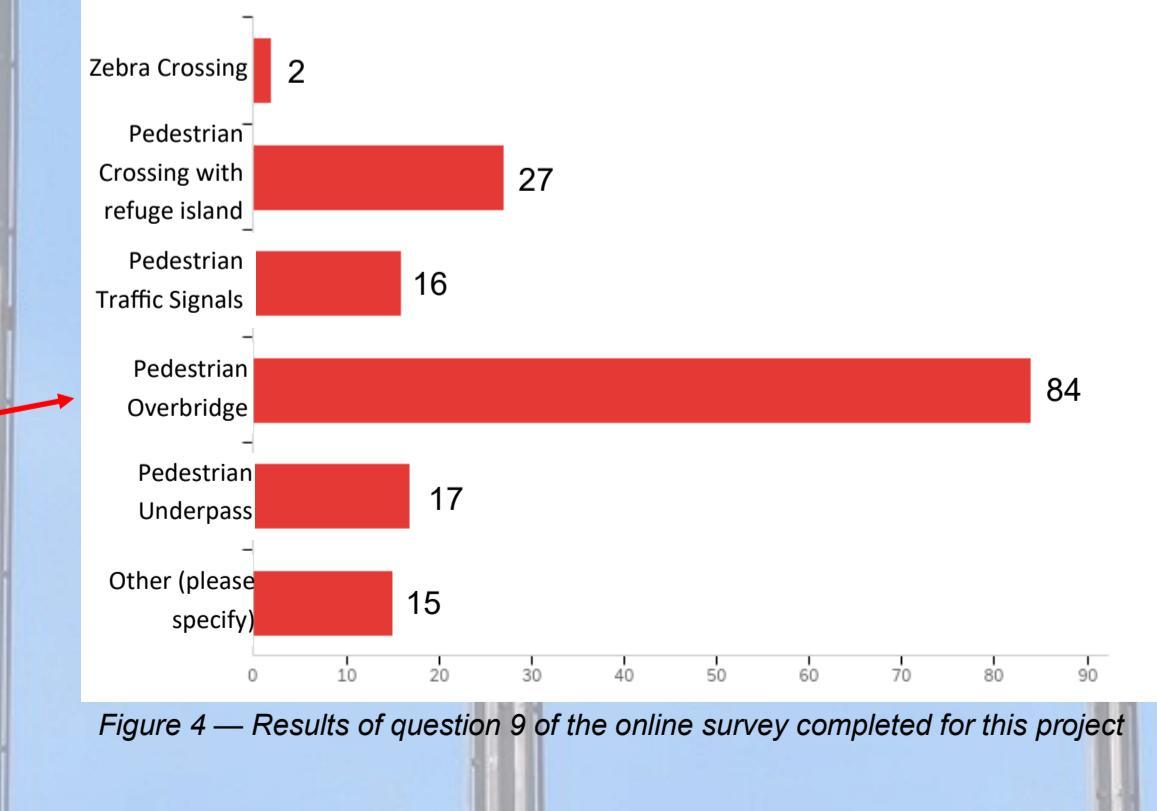
The graph to the right, figure 4, represents what participants would prefer to use to cross SH88. A footbridge was the most popular option. This option was preferred over three times more than the next highest, the zebra crossing with refuge islands in the middle.

Q9 - What type of crossing would you like to be able to use to cross SH88 to access the share path from residential areas, such as St Leonards or Sawyers Bay?

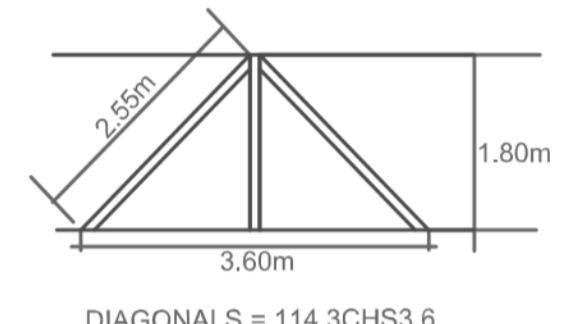
Figure 5 — Cross section of one bay of the steel truss designed

Calculations were done from first principles, using NZS 3404:1997 and SNZ HB 8630:2004, to determine the section sizes required with a minimum wall thickness. A 150SHS5.0 was adequate for the chords, and a 114CHS3.6 for the diagonal members, as seen in figure 5 and figure 6.

DIAGONALS = 114.3CHS3.6 TOP CHORDS = 150SHS5.0

A truss design was used for this foot bridge. This allowed the design to be lightweight and aesthetically pleasing. Square Hollow Sections (SHS) were used as the top and bottom chords, and Circular Hollow Sections (CHS) for the diagonal members. This allowed the bridge to have adequate strength under dead and live loads whilst keeping the design aesthetics pleasing.

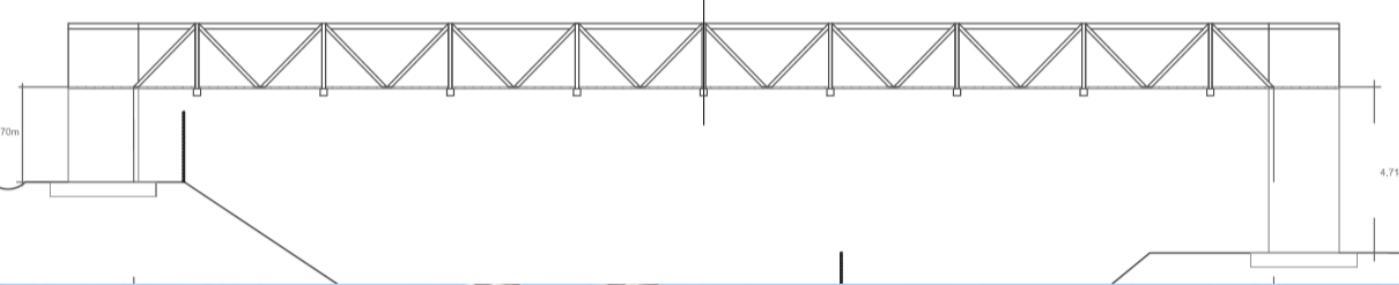
Figure 6 — Cross section drawing of the main structure of the foot bridge designed. SH88 and the rail corridor can be seen beneath the bridge

Due to restrictions from NZTA and NZ standards, the height of the bridge had to be designed at 6.5m above the road surface. The access ramps could not be at a gradient greater than 8% and a landing pad of 1.5m was required every 9m. Due to the

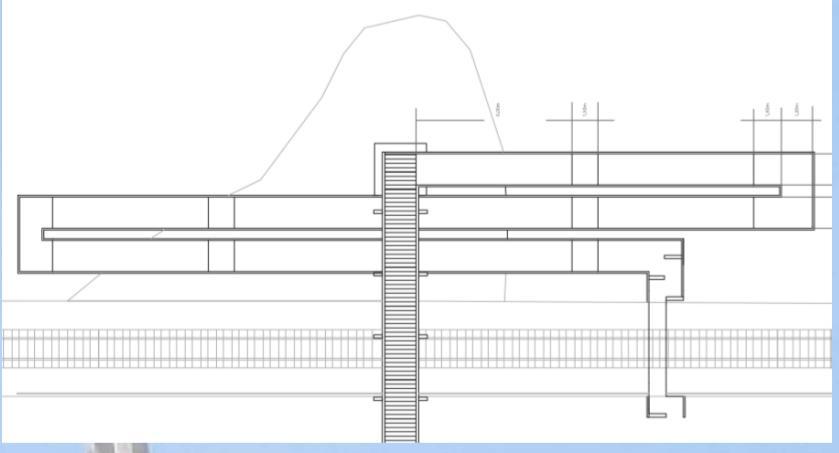
Figure 7 — Plan view of the access ramp designed from off the rocky outcrop with the rail crossing on the right hand side

path between the road and the railway, a rail crossing was necessary, as seen in figure 7.
